# Natural Heritage Audit - Watercourses and water dependent habitats

## Transforming the Trent Headwaters

A Report To: Staffordshire Wildlife Trust  
Report Number: RT-MME-181387  
Date: 19th September 2025

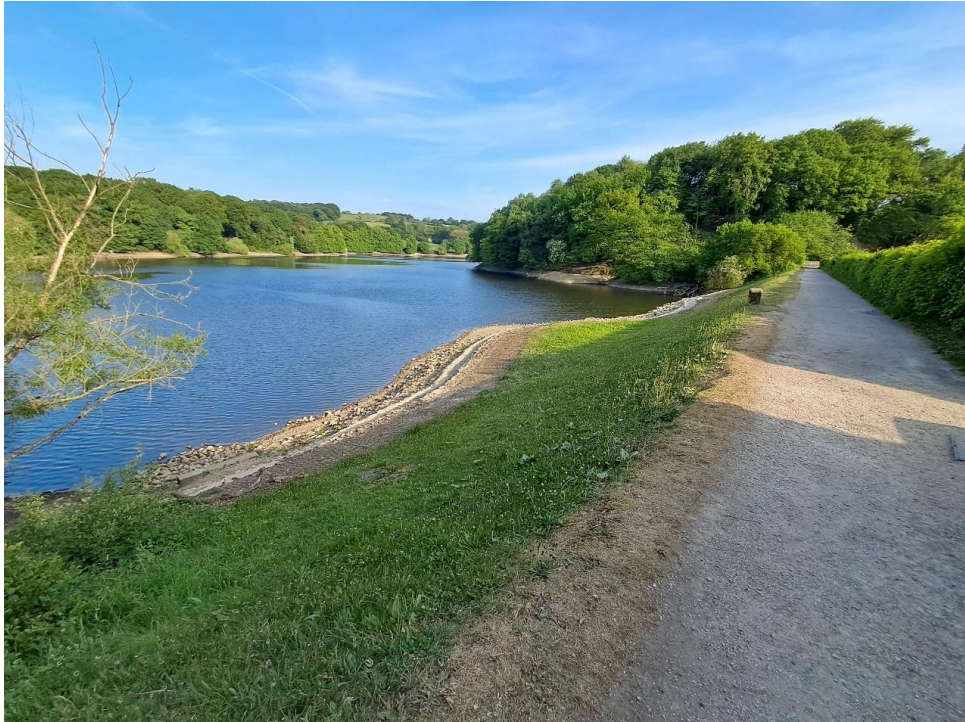
<p><i>Figure 12: Photograph taken at Knypersley Reservoir</i></p> <p>Additional photos are available in the separate 'Appendix 8 – Survey photos catalogue'.</p>																			
<b>Other information</b>

<b>Constraints</b>	<p>This site has frequent visitors who use the network of footpaths and tracks. Any large scale works would likely interrupt this access. A feeder channel which diverts water to the upper Reservoir basin intercepts numerous ditches and smaller feeder streams. Details of discharge rates of this feeder should be examined to determine the impact this has on the water volume and refill rate of the upper Reservoir basin. Changes to the flows along this channel could impact the levels in the upper basin as flow would be partially diverted into the lower basin.</p> <p>Rewetting of woodland and slowing the flow in wetlands might cause overspill across footpaths making access more difficult during wet periods.</p>
<b>Date of Site Visit</b>	15th May 2025
<b>Priority Overview</b>	High Priority
<b>Estimated budget</b>	<p>Total cost = £200,000</p> <p>Designs = £10,000</p> <p>Capital works = £190,000</p>

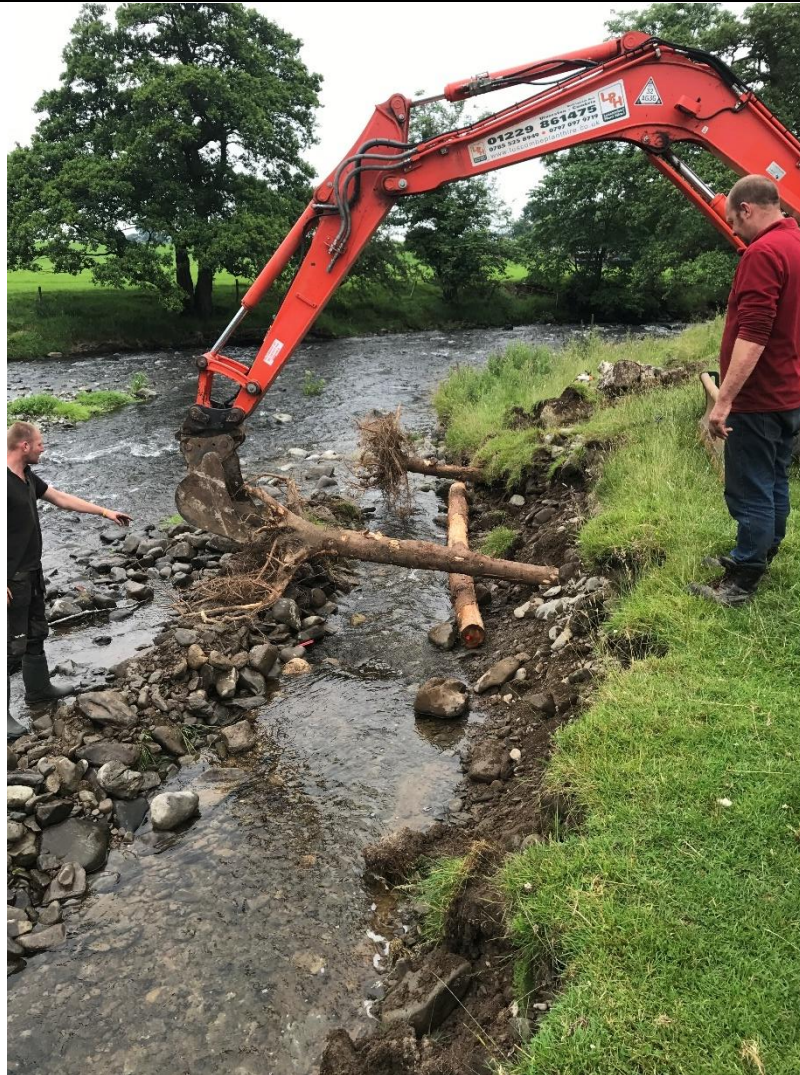
root bole flow deflectors. Gravel supply from the proposed restoration measures will be a gradual process and could take several years (and several higher flow episodes) to generate a measurable increases in gravels. This seeding technique would give the process and jump start and provide a much quicker improvement through assisted natural recovery.
--	---

Figure 18. Photograph showing installation of Larch root bole flow deflectors.

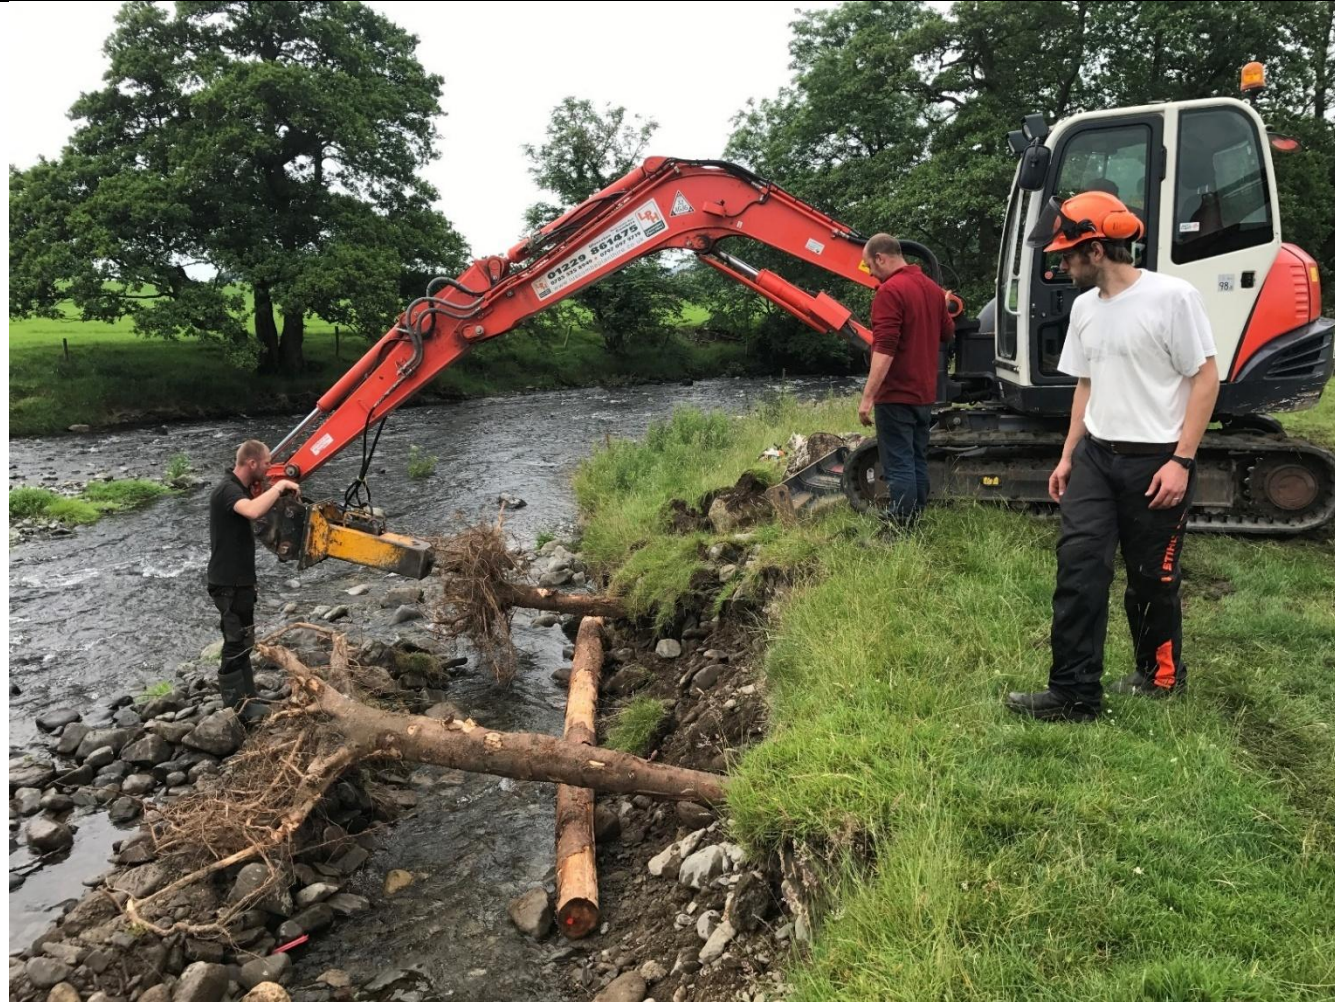
*Figure 19. Photograph showing installation of Larch root bole flow deflectors.*

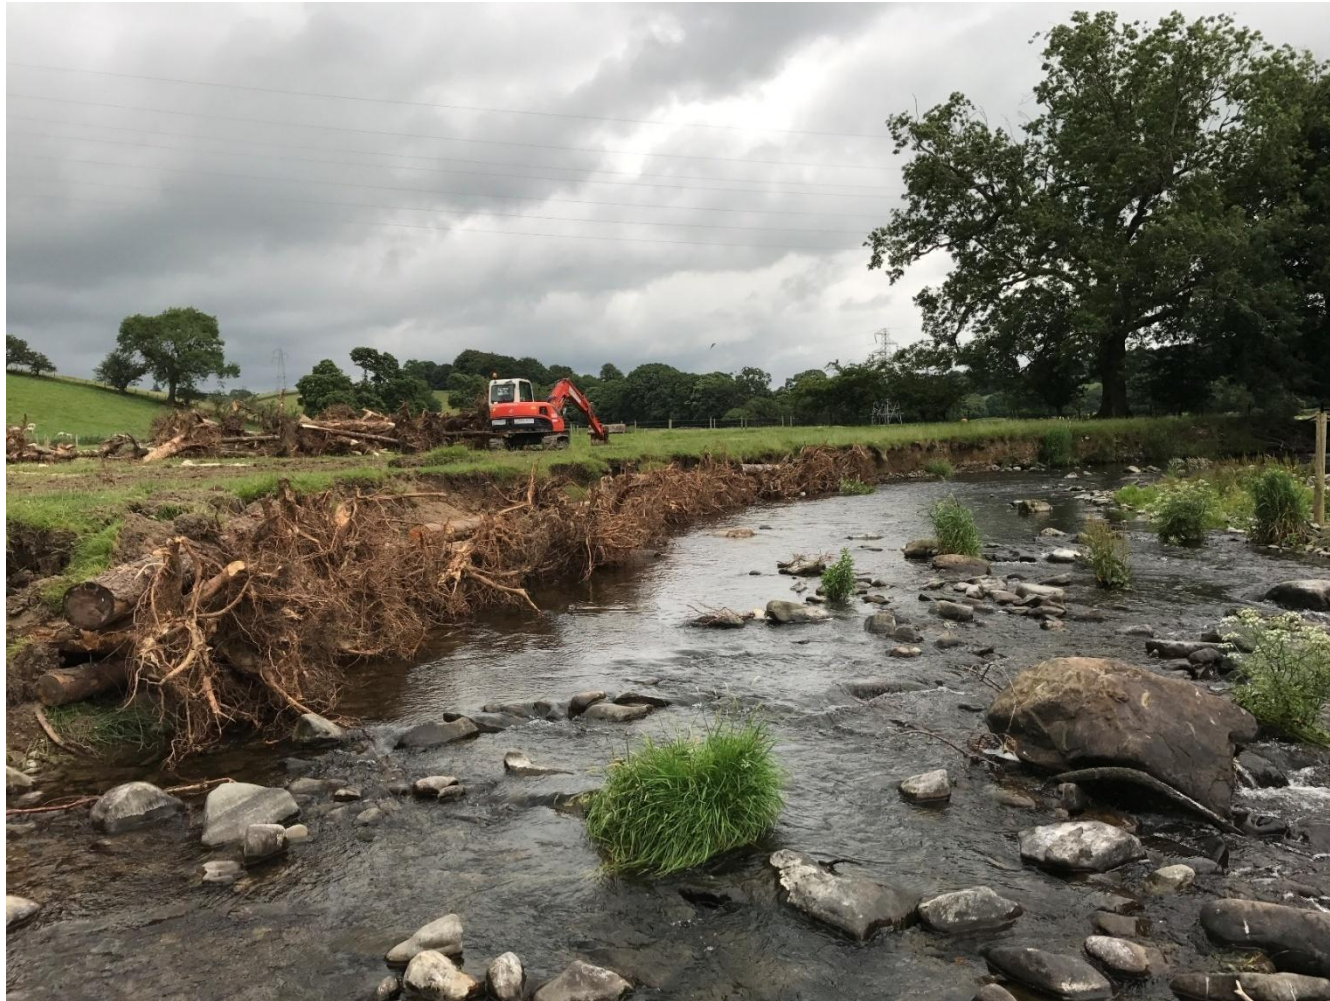
*Figure 20. Photograph showing installation of Larch root bole flow deflectors.*

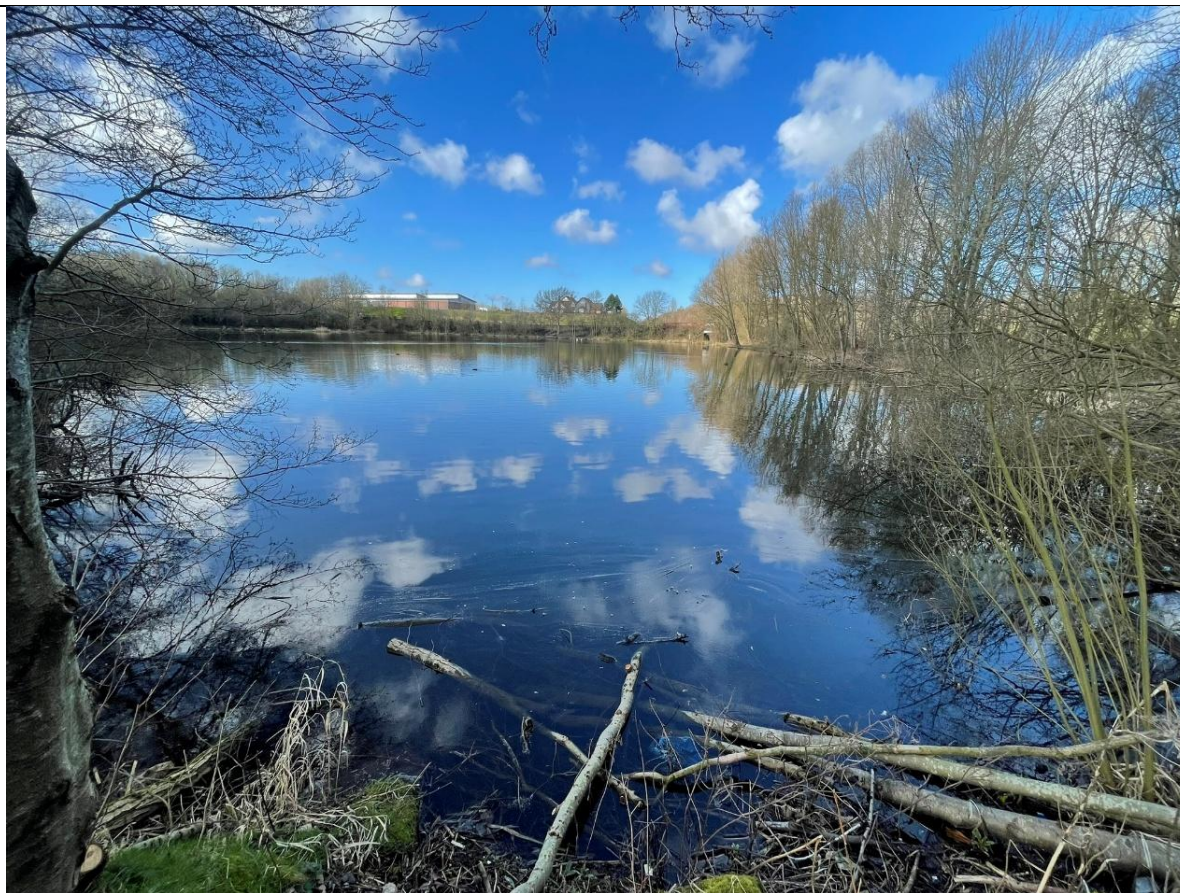
*Figure 24. Photograph taken at Holden Lane Pools.*

<b>Constraints</b>	Rewetting of the eastern region of the site may impact on the footpaths in this area. Remedial work may be necessary as part of any rewetting to raise or adapt the footpaths to allow for continued public access.
<b>Date of Site Visit</b>	28 <sup>th</sup> Feb 2025

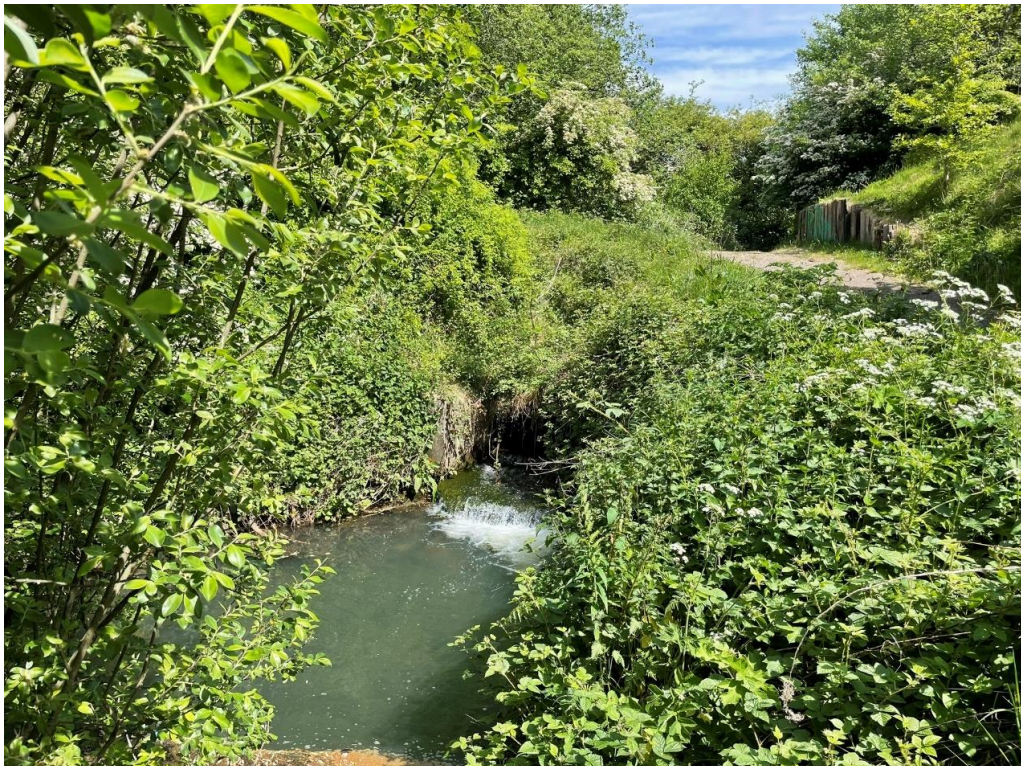
</div> <p>Figure 50: Photograph taken at Cockster Brook.</p> <p>Additional photos are available in the separate ‘Appendix 8 – Survey photos catalogue’.</p>																																																												
<b>Other information</b>	Close liaison with Environment Agency will be required to determine feasibility of removal or modification of trash screens to reestablish unimpeded movement within the channel.
